Flight Comment

Directorate of Flight Safety

The Canadian Forces Flight Safety Magazine

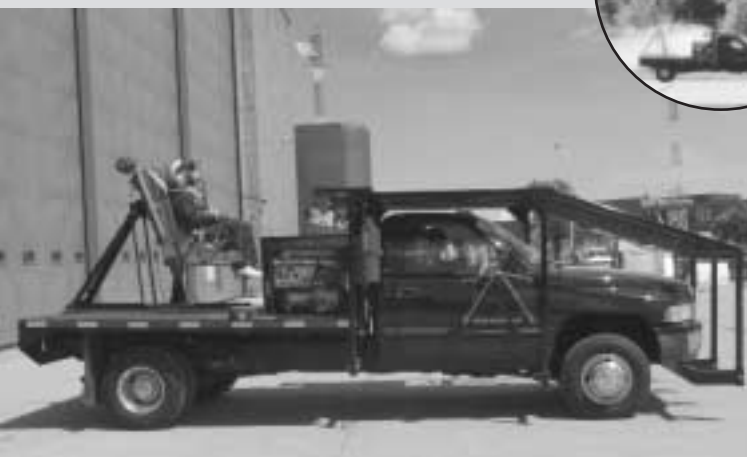
ejection envelope. In order to test the ARAD from ground level to simulate the low-altitude, low-speed ejection, a test vehicle was needed. And what a vehicle it was — a jet black standard 1998 Dodge 3500 Series Chassis Cab Model truck powered by an 8L, 10 cylinder gas engine capable of speeds of up to 175 kph, aptly named “Black Thunder.” It has a protective cage enclosing the cab in case of direct hit from the ejection seat after firing. The rear of the cage also serves as protection for the passengers in case of a rollover. All of the test equipment (generators, cameras, strobes, radio, fire extinguishers and other test components) including the ejection seat and the “dummy” were mounted on an 8-by-10 foot flat deck located behind the cab.

An even bigger challenge was to create a test bed for in-flight ejection seat testing. The team modified a CT-133 aircraft. They removed the rear seat and all rear cockpit controls from the 2-seater, low-wing monoplane and installed a test ejection seat. Among many of the changes made to the aircraft, a stainless steel blast shield was put in to protect the rear cockpit and reduce the chances of gases and smoke wafting to the forward cockpit. They also removed the rear cockpit plexiglas so there would be an unobstructed path for the ejection seat to clear the aircraft. Extensive testing on the ARAD began in Dec 99 and was done in a phased approach.

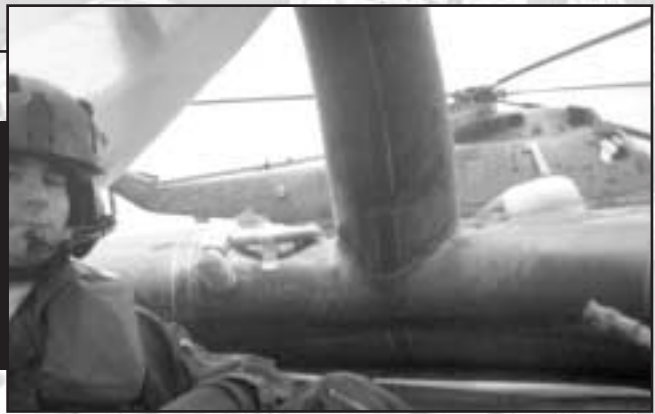
Crewmember in life-raft, immediately after ditching.

Approximately 25 minutes after launching from HMSC PROCTEUR, a hot Main Transmission Gearbox (MGB) was noted. As the crew returned to land, cockpit indications were assessed as severe enough to require a controlled ditching. After the crew successfully egressed uninjured, the aircraft sank, suffering "A" category damage.
